NAVAL POSTGRADUATE SCHOOL Monterey, California

THESIS

FATIGUE CHARACTERISTICS AND MICROSTRUCTURAL ANALYSIS OF THERMOMECHANICALLY-PROCESSED, HIGH-MAGNESIUM ALUMINUM-MAGNESIUM ALLOY

June 1981

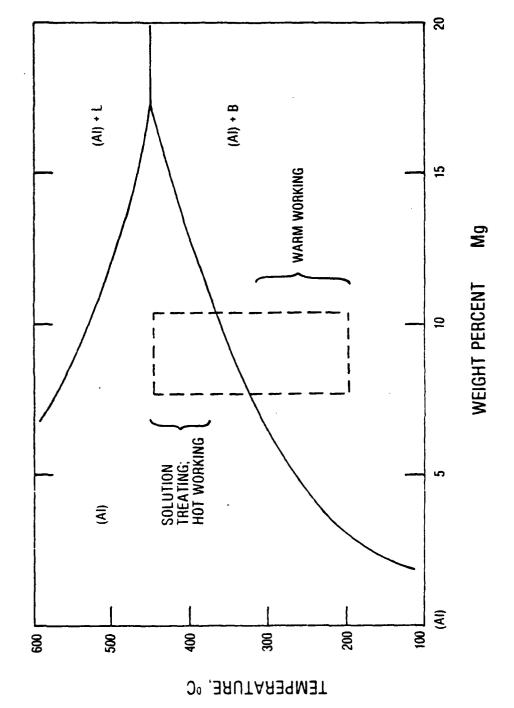
FIGURE 1. Partial Aluminum-Magnesium Phase Diagram.

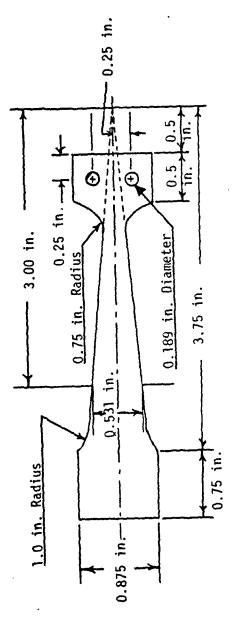
SPECIMEN THICKNESS 0.1 INCHES

FIGURE2. Fatigue Test Specimen Design Utilized for This Study

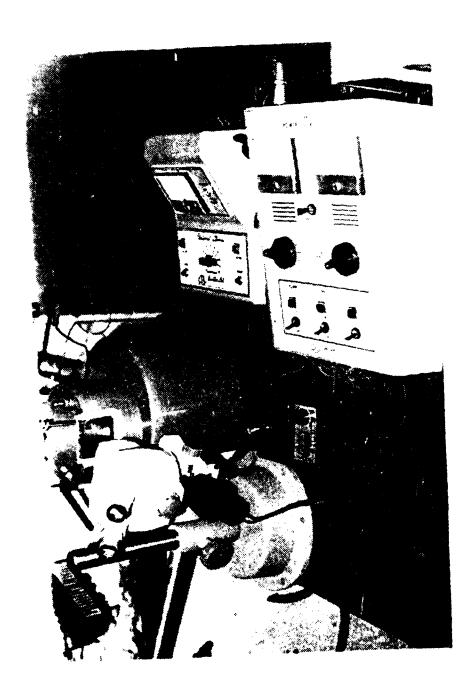
Hectrolyte Thinnine Apparatus Utilized for Thin Foil Preparation oposer supplies included) Haurt 5.

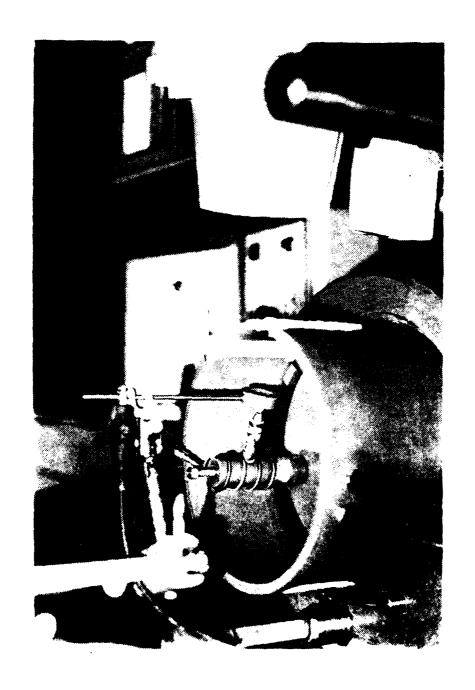
Positioning of specimen holder and jet in final preparation for electrolytic thinning of foils FIGURE 5.

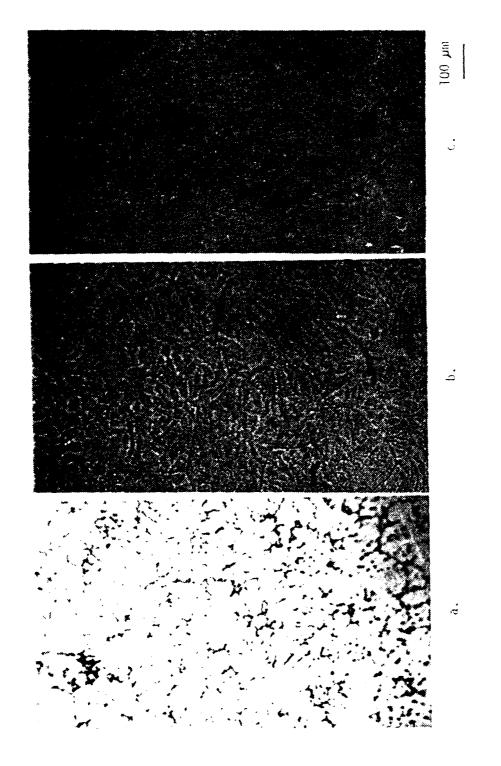
Al-8.44 wt pct Mg-D, 40 wt pct Cu microstructure: (a) asseast; (b) solution treated and water-quenched; (c) solution treated and water-quenched; and oil-quenched FIGURE 6.

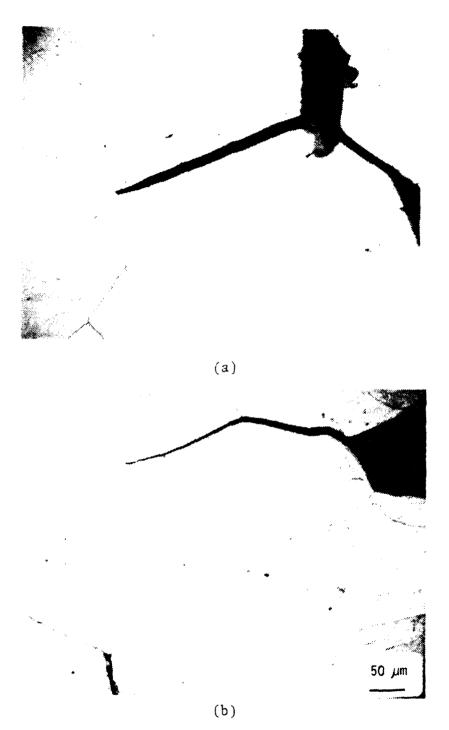
FIGURE 7. Regions of intergranular cracking in billets of A1-8.14 wt pct Mg-0.40 wt pct Cu solution treated and water-quenched. Cracking occured in both billets after 2 passes in rolling mill (rolling temperature 300°C)

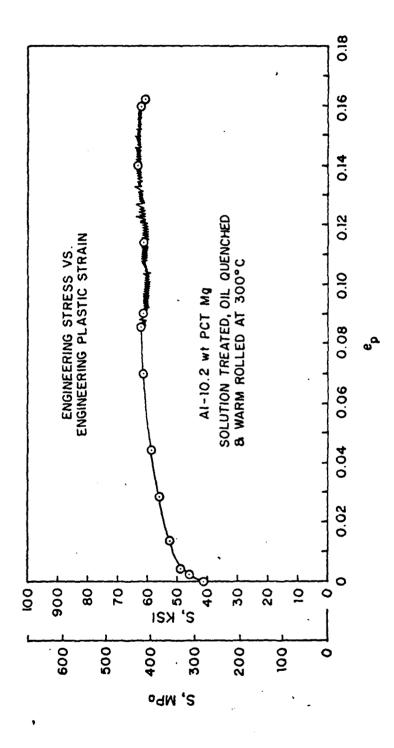
Engineering Stress vs Engineering Plastic Strain for Al-10.2 wt pct Mg Solution greated Oil-Quenched and Warm-Rolled at 300°C FIGURE 8.

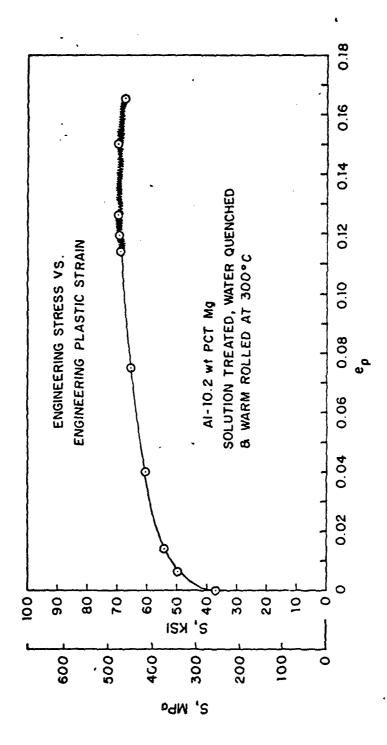
Engineering Stress vs Engineering Plastic Strain for Al-10.2 wt pct Mg Solution Treated, Water-Quenched and Warm-Rolled at $300^{\circ}\mathrm{C}$ FIGURE 9.

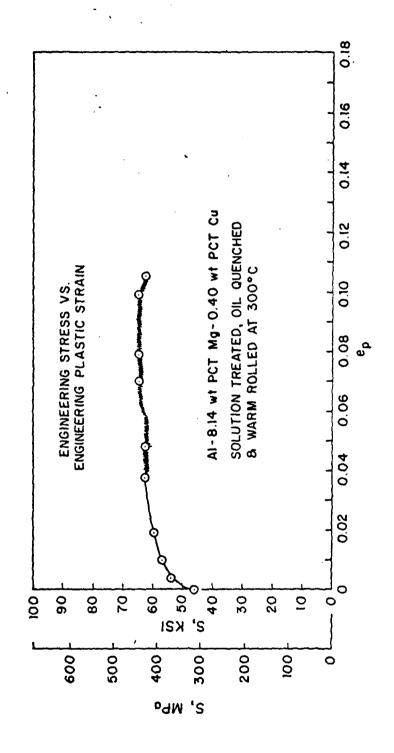
Engineering Stress vs Engineering Plastic Strain for Al-8.14 wt pct Mg-0.40 wt pct Cu, Solution Treated, Oil-Quenched and Warm-Rolled at 300°C FIGURE 10.

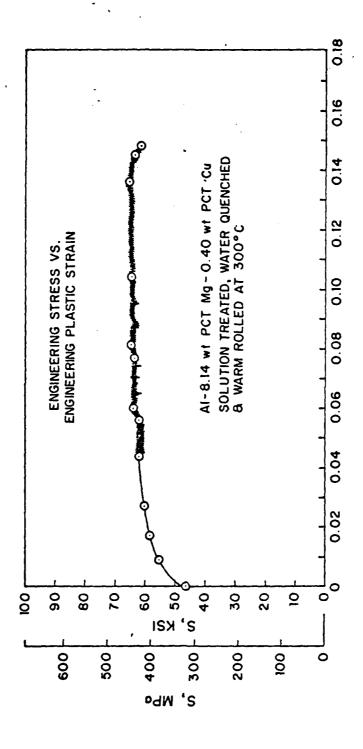
Engineering Stress vs Engineering Plastic Strain for Al-8.14 wt pct Mg-0.40 wt pct Cu, Solution Treated, Water-Quenched and Warm-Rolled at 300°C FIGURE 11.

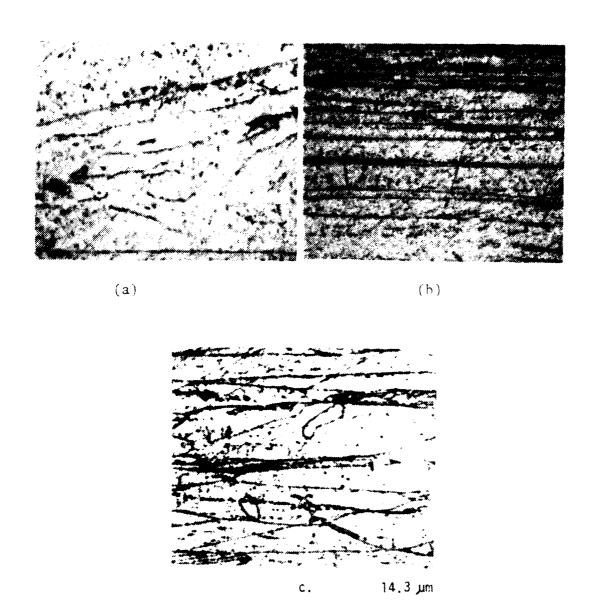
FIGURE 12. Optical micrographs of the A1-10.2 wt pct Mg alloy, oil-quenched from homogenization: (a) longitudinal; (b) long transverse; (c) short transverse

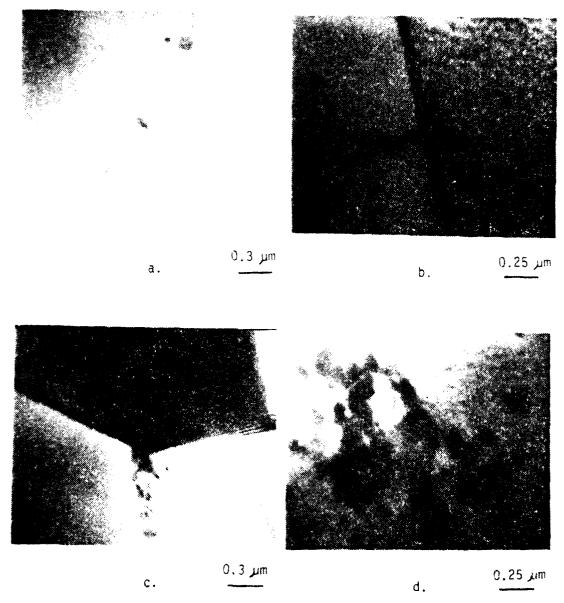
FIGURE 18. Thin foil micrographs of A1-10.2 wt pct Mg, solution treated and oil-quenched, indicating: (a) precipitates forming within GP zones, with dislocations pinned; (b) grain boundary, with GP zones well defined to the right through tilting; (c) grain boundary triple point with precipitates nucleation in the grain boundaries; (d) precipitates nucleated within GP zones

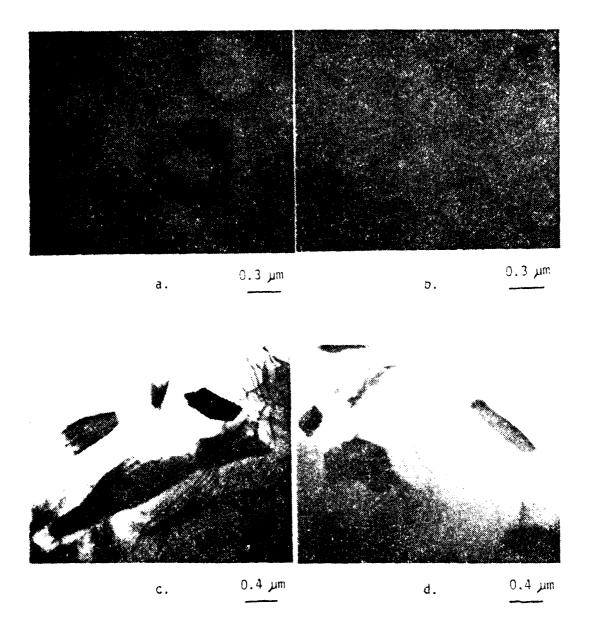
FIGURE 19. Thin foils of Al-10.2 wt pct Mg artificially aged (a) oil-quenched from homogenization showing sites originally occupied by second phase particles; (b) oil-quenched from homogenization, relatively free of precipitates with small dislocation density; (c) and (d) water-quenched from homogenization showing precipitate growth during aging at 300°C with dislocations believed generated through increments volume occupied by second phase particles

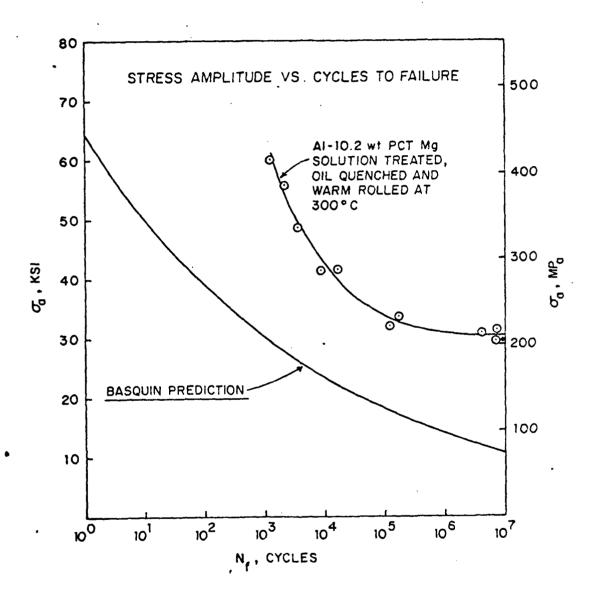
FIGURE 21. Stress Amplitude vs Cycles to Failure for A1-10.2 wt pct Mg Solution Treated, Oil-Quenched and Warm-Rolled at 300°C

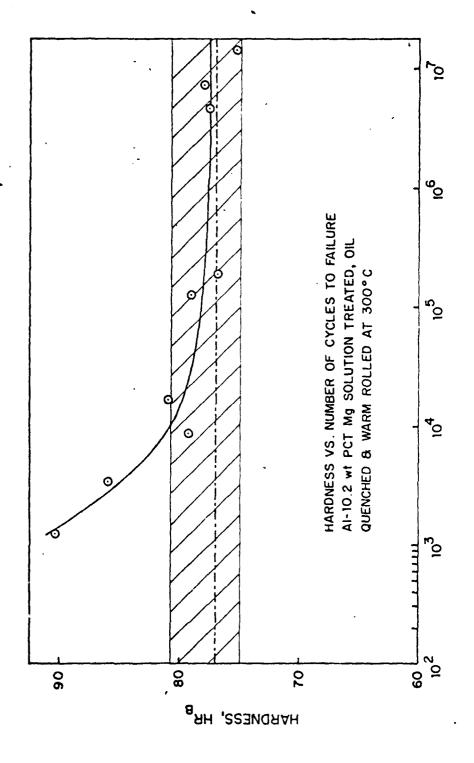
Hardness vs number of cycles to failure for Al-10.2 wt pct Mg solution treated, oil-quenched and warm-rolled at $300^{\circ}\mathrm{C}$, Hlustrating cyclic hardening under low cycle fatigue conditions FIGURE 22.

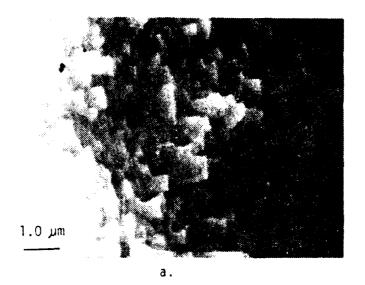
FIGURE 24. Thin Foil TEM micrographs of A1-10.2 wt pct Mg solution treated, oil-quenched and warm-rolled at 300°C, after being tested under low cycle fatigue conditions (a) foil taken from a region adjacent to the main fracture surface parallel to the rolling plane (b) foil taken from a region heavily concentrated with secondary cracks (parallel to the rolling plane)

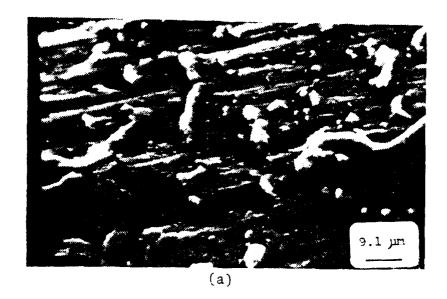
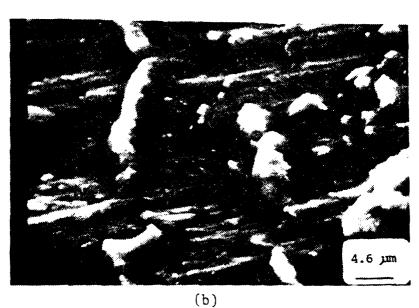
FIGURE 25. Scanning Electron Fractographs of stage II crack growth region of a specimen of A1-10.2 wt pct Mg, oil-quenched from homogenization. Failure occurred after 3300 cycles of fully reversed bending fatigue; (a) 1100x; (b) 2200x

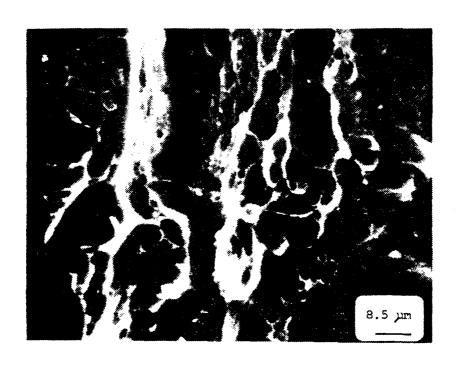
FIGURE 26. Overload region of same specimen as Figure 27 at 1175x on the Scanning Electron Microscope

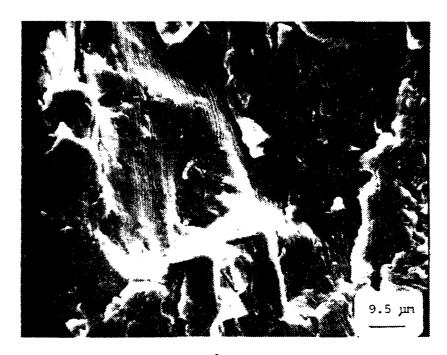
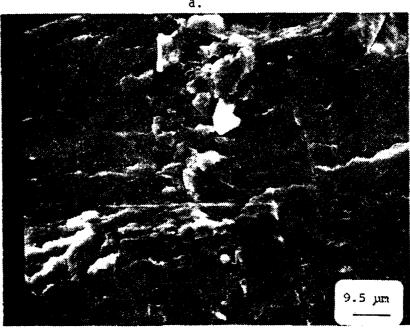
FIGURE 27. (a) Regions of Stage II crack growth in a specimen of A1-10.2 wt pct Mg oil-quenched from homogenization temperature which fractured after 1.81 x 10° cycles: (b) overload region of the same specimen (SEM x 1050)

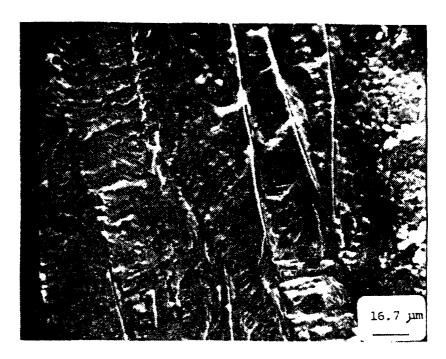
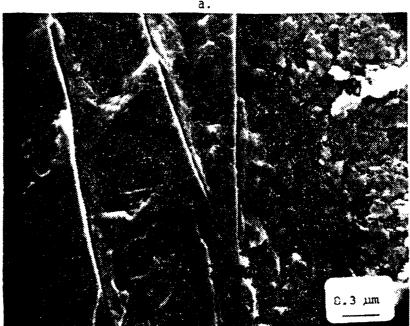
FIGURE 29. Transition from stage I growth to stage II growth in A1-10.2 wt pct Mg, oil-quenched from homogenization and warm-rolled at 300°C. failure occurred after 4.4 x 106 cycles of fully resersed bending fatigue.

(a) SEM fractograph x600 (b) SEM fractograph x1200

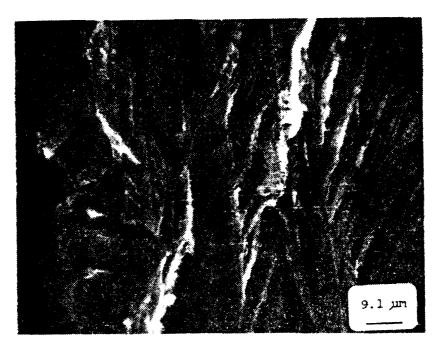
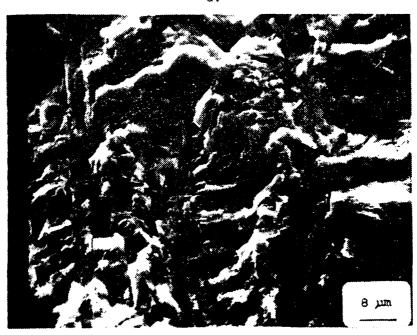
FIGURE 30. (a) Fully developed Stage II crack growth or same specimen shown in Figure 29; magnification 1100x SEM; (b) Stage III fracture appearance; magnification 1250x SEM

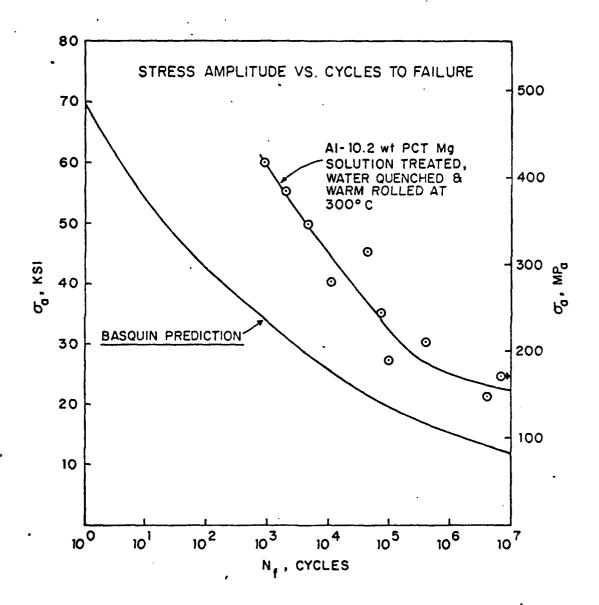
FIGURE 31. Stress amplitude vs cycles to failure for A1-10.2 wt pct Mg solution treated, water-quenched and warm-rolled at 300°C

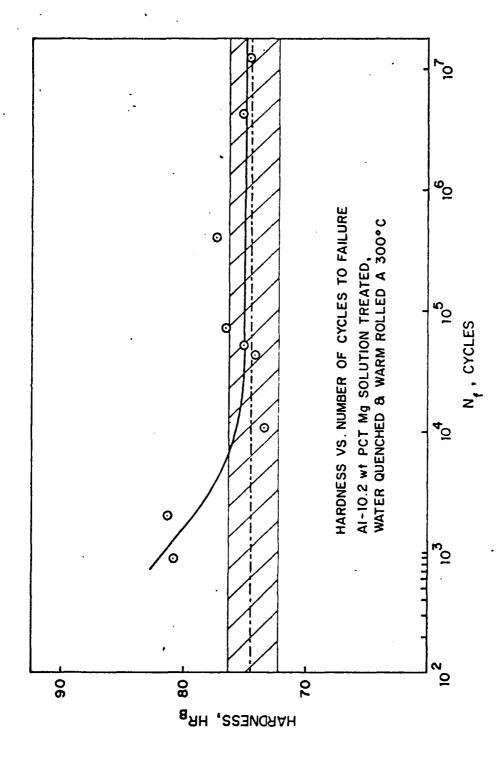
Hardness vs number of cycles to failure for Al-10.2 wt pct Mg solution treated, water-quenched and warm-rolled at $300^{\rm o}{\rm C}$. Illustration cyclic hardening under low cycle fatigue conditons FIGURE 32.

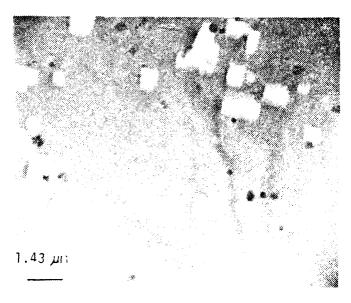
FIGURE 34. Thin foil TEM micrograph of A1-10.2 wt pct Mg solution treated, water-quenched and warm-rolled at 300°C after being tested under low cycle fatigue conditions; (a) some indication of larger precipitates (b) region where Volume fraction of precipitates is increased over the as-rolled condition (dark blotches in (b) are artifact from electrolyte thinning)

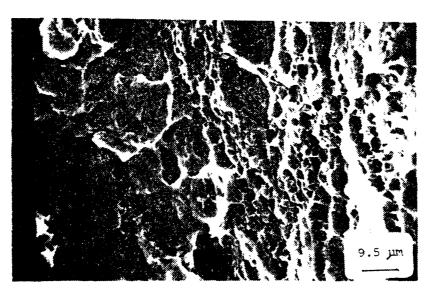
FIGURE 35. SEM fractographs of A1-10.2 wt pct Mg, solution treated, water-quenched and warm-rolled at 300°C, in which fracture occurred after 3400 cycles: (a) Stage II crack growth x1050; (b) overload region x1050

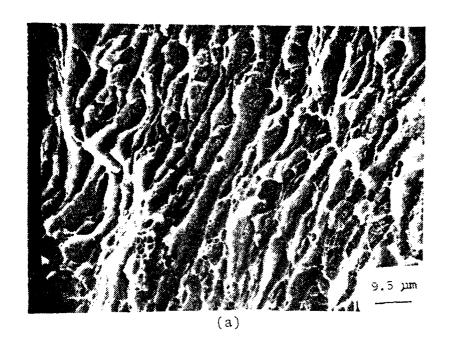
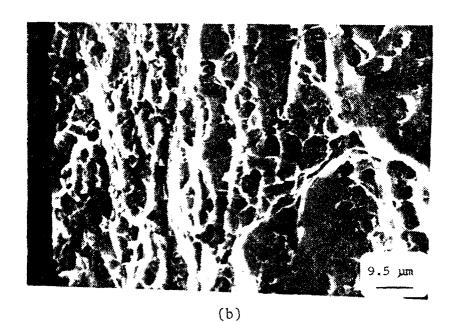
FIGURE 36. SEM fractographs of A1-10.2 wt pct Mg, water-quenched and warm-rolled at 500°C, in which fracture occurred after 10600 cycles: (a) Stage II striations x1050 and (b) Stage III (overload region) x1050

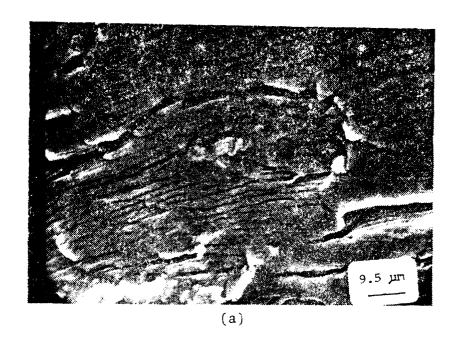
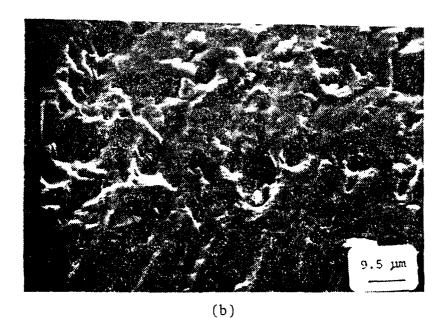
FIGURE 38. SEM fractographs of Al-10.2 wt pct Mg, solution treated, water-quenched and warm-rolled at 300°C, in which failure occurred after 4.2 x 10⁶ cycles: (a) Stage II crack growth x 1050; (b) Stage III crack growth x1050

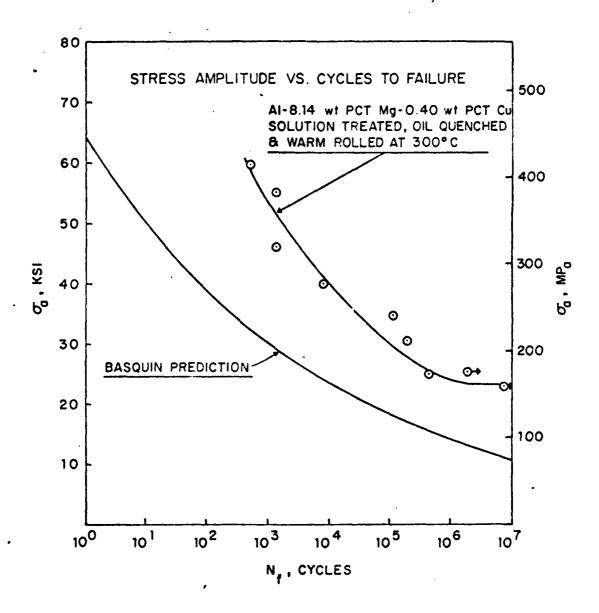
FIGURE 39. Stress amplitude vs cycles to failure for Al-8.14 wt pct Mg-0.40 wt pct Cu solution treated, oil-quenched and warm-rolled at 300°C

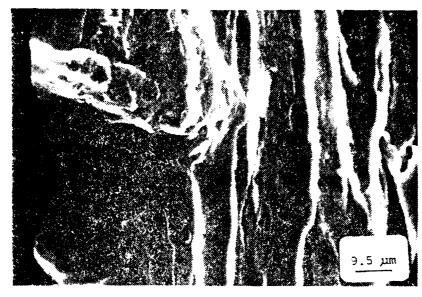
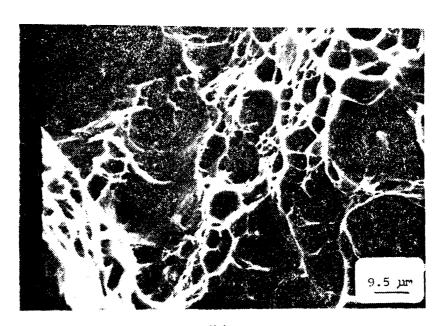
FIGURE 41. SEM fractographs of a specimen of A1-8.14 wt pct Mg-0.40 wt pct Cu, solution treated, oil-quenched and warm-rolled at 300°C, in which failure occurred after 1400 cycles: (a) Stage II crack growth x1050; (b) Stage III crack growth x1050

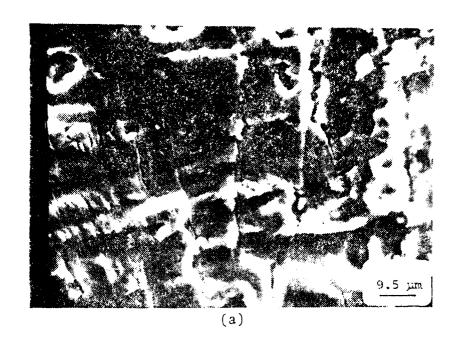
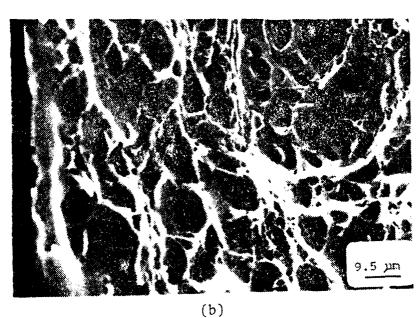
FIGURE 42. SEM fractographs of a specimen of A1-8.14 wt pct Mg-0.40 wt pct Cu solution treated, oil-quenched and warm-rolled at 300°C, in which failure occurred after 110200 cycles; (a) Stage II crack growth x1050; (b) Stage III crack growth x1050

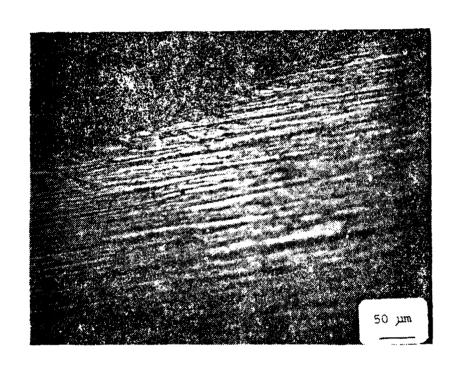
FIGURE 43. Microcrack formation on the surface of A1-8.14 wt pct Mg-0.40 wt pct Cu solution treated, oil-quenched and warm-rolled at 300°C. test terminated after 10⁷ cycles without failure

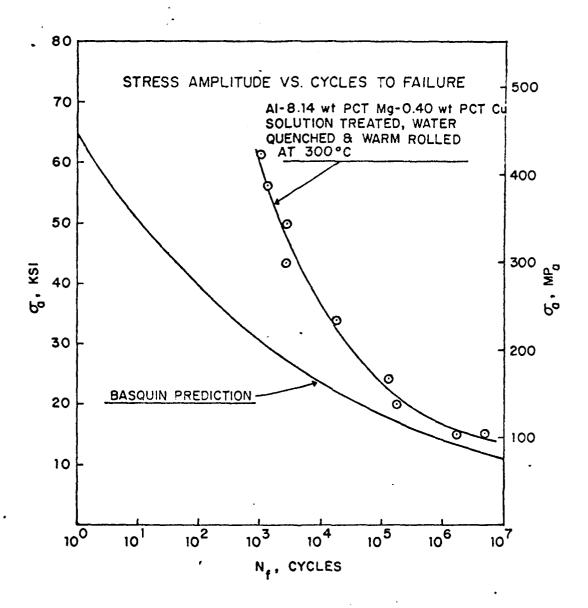
FIGURE 44. Stress amplitude vs cycles to failure for A1-8.14 wt pct Mg-0.40 wt pct Cu, solution treated water-quenched and warm rolled at 300°C

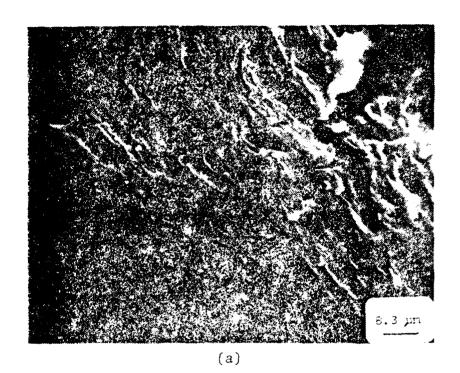
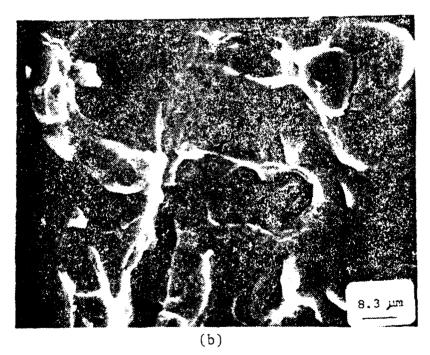
FIGURE 46. SEM fractographs of A1-8.14 wt pct Mg-0.40 wt pct Cu, solution treated, water-quenched and warm-rolled at 300°C; in which failure occurred after 2700 cycles: (a) Stage II crack growth x1200; (b) Stage III crack growth x1200

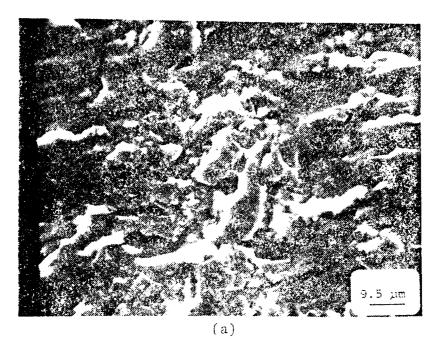
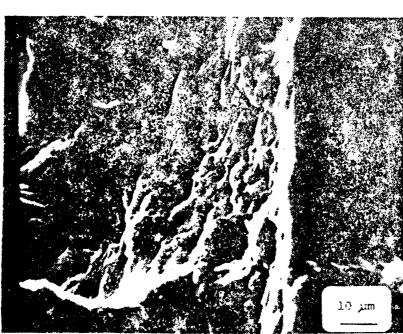
FIGURE 47. SEM fractographs of A1-8.14 wt pct Mg-0.40 wt pct Cu, solution treated, water-quenched, and warm-rolled at 300°C, in which failure occurred after 13.4 x 10 ° cycles: (a) Stage II crack growth x1000; (b) Stage III crack growth x1050
